# **Effective Use of In-line Inspection Technologies to Support Pipeline Integrity Management**

PPSA Annual Seminar

19th November 2014

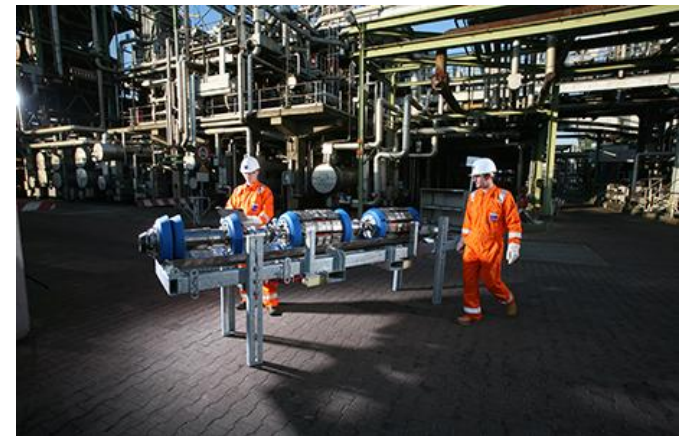
- MACAW Engineering has been supporting Chevron North Sea Ltd (CNSL) with the implementation of their integrity management process since 2006
- Support has focussed on ensuring that CNSL maximise the value from their in-line inspection (ILI) campaigns:
  - Pre-inspection support (ILI tool selection and timing of ILI)
  - Post-inspection support ('verification' of ILI report, integrity assessment of ILI results, comparison of repeat ILI data, recommended updates to corrosion management strategy)
- Key to the success of the ILI campaigns has been combining corrosion knowledge with an understanding of the capabilities and limitations of available ILI technology
- This paper aims to share some key learning points in order to improve the input that ILI has into an overall pipeline integrity management programme

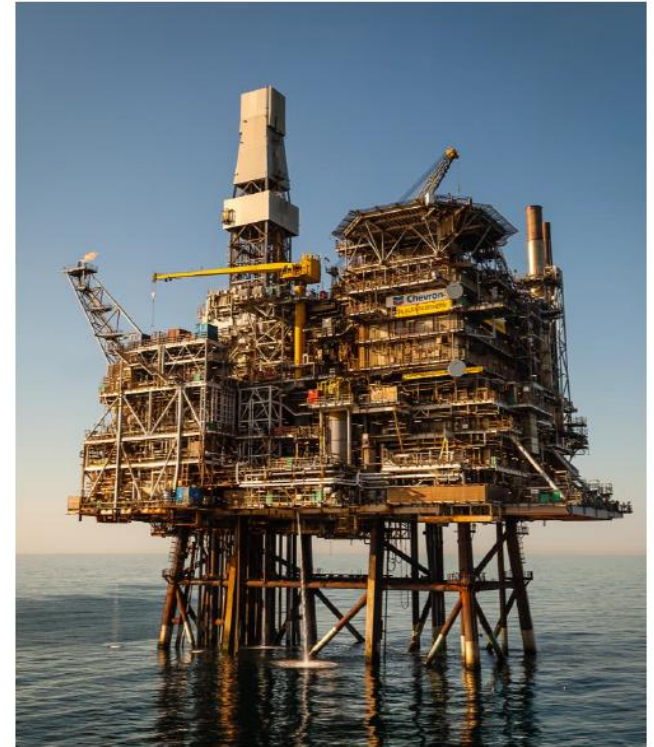
CNSL operates more than 25 pipelines across three operated assets in the UK North Sea, **Alba**, **Captain** and **Erskine**, with pipelines service life of up to 20 years.

- Produced hydrocarbon fluids
- Gas import/export
- Injection water for enhanced hydrocarbon recovery
- Chemicals/hydraulic fluids for flow assurance, asset integrity and subsea equipment controls

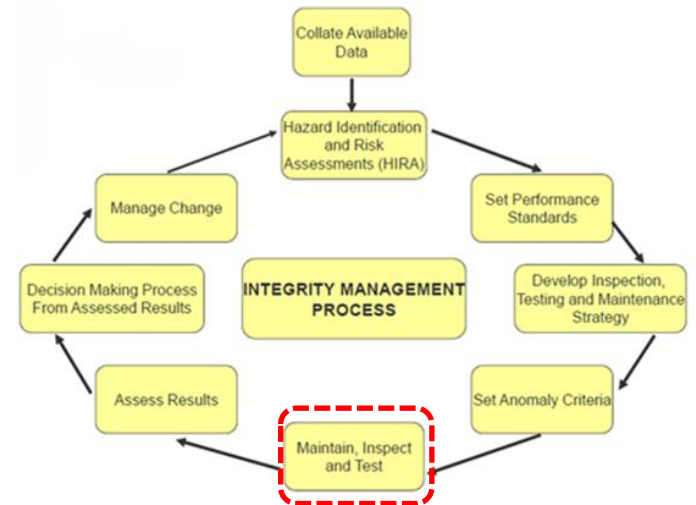
# THE ROLE OF ILI IN INTEGRITY MANAGEMENT

- Knowledge of pipeline history and required future use
- Understanding of active corrosion threats and likely corrosion mechanisms present in pipeline
- Knowledge of capabilities and limitations of ILI tools
- Sound integrity knowledge to be able to combine corrosion management experience with ILI data to estimate remaining life

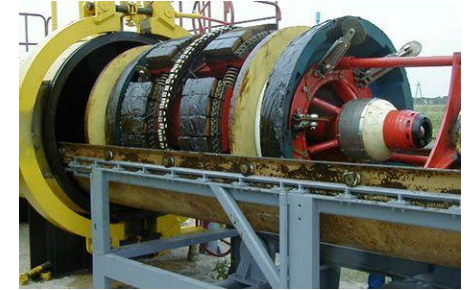
***Magnetic Flux Leakage***

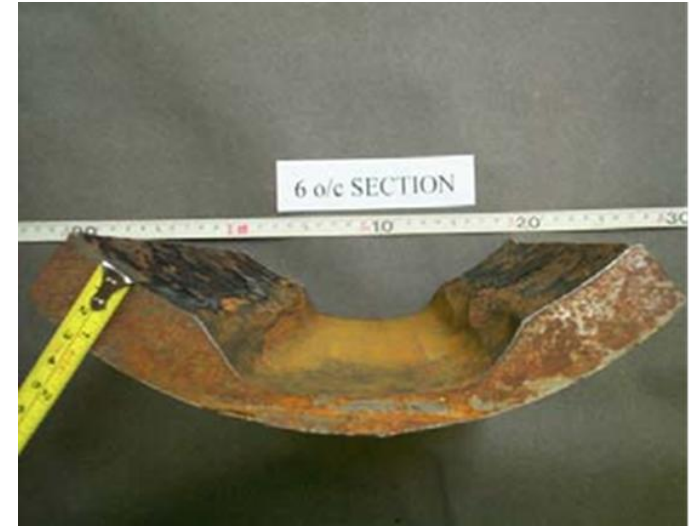
*Channelling corrosion in Strathspey W.I. pipeline which was operated under similar conditions*

- Background:
  - 12" Alba Water Injection Pipeline, commissioned in 1998
  - Previously inspected using MFL technology on two occasions (2006 & 2009)
  - Inspections both reported internal corrosion throughout the pipeline, thought to have been caused by elevated O<sub>2</sub> levels
  - Corrosion risk assessment indicated potential for channelling corrosion
  - MFL tools known to be relatively insensitive to smooth channelling corrosion
  - No channelling corrosion reported by MFL inspections but indirect evidence (features at girth welds and increased magnetisation at the 6 o'clock position) supported potential for channelling

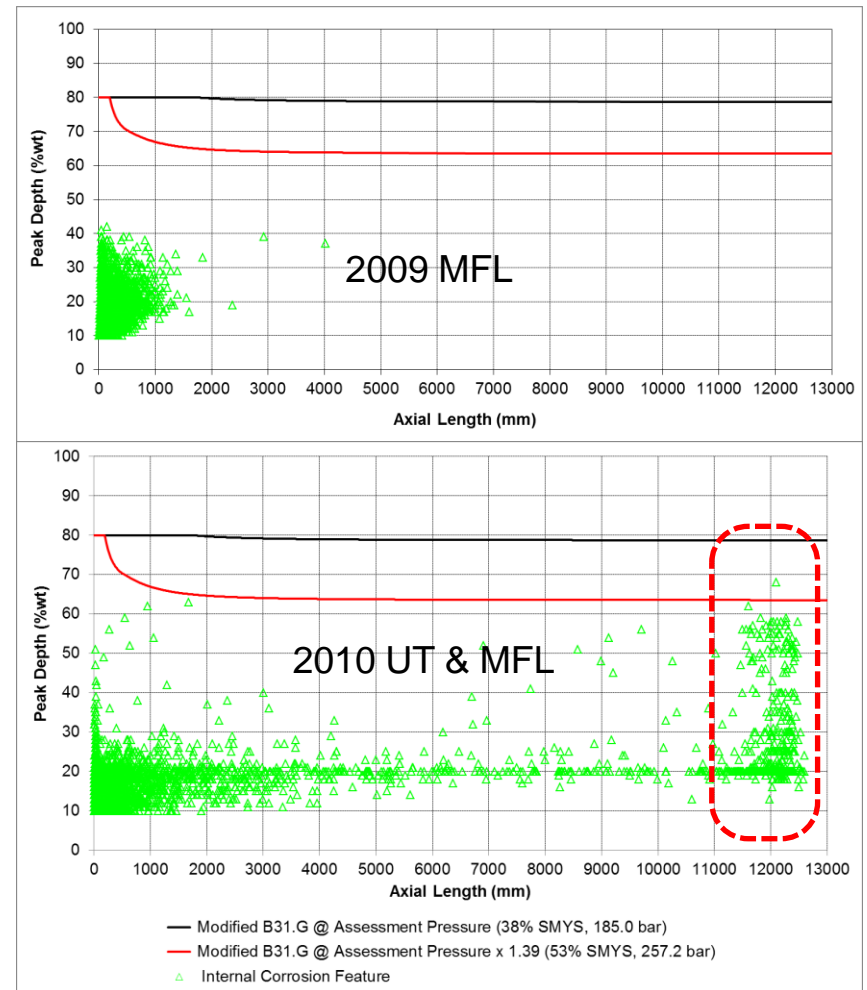
- Approach for next ILI:
  - Pipeline was re-inspected in 2010 using both MFL and UT technology
  - MFL was used to enable a direct comparison against the previous data
  - UT was used to improve detection capability with reference to channelling
- UT reported significant channelling corrosion in the bottom of the pipeline
- Comparison of 2009 and 2010 data highlights significant differences in depths and lengths of reported features

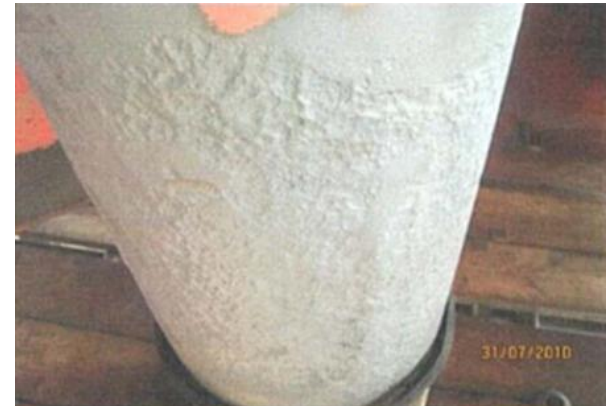
- 16” Captain Oil Export riser
- GVI reported an area of corrosion immediately above the neoprene splash zone coating. Corrosion was subsequently repaired.
- Although records of repair (including photographs) were retained, it was not clear if and how far the neoprene coating was stripped back
- Following the repair, the pipeline was internally inspected and external corrosion was reported at various locations on the riser
- Comparison of repeat ILI data indicated some features had grown since previous inspection
- Initial comparison between ILI data and riser drawings were inconclusive and there was uncertainty whether all active corrosion had already been repaired

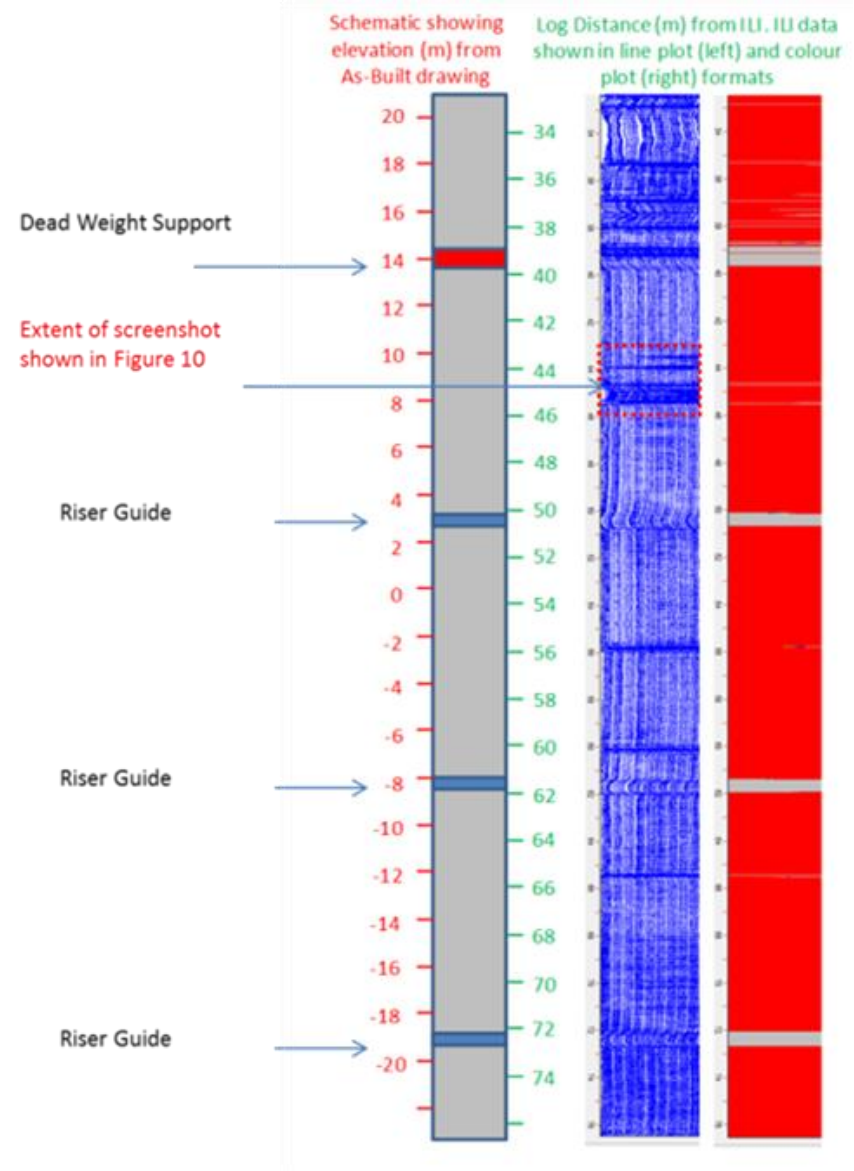
- ILI data aligned with riser schematic
- Alignment used ILI signals to increase accuracy
- Based on alignment, clear guidance was given to investigation team to enable positive identification of riser corrosion

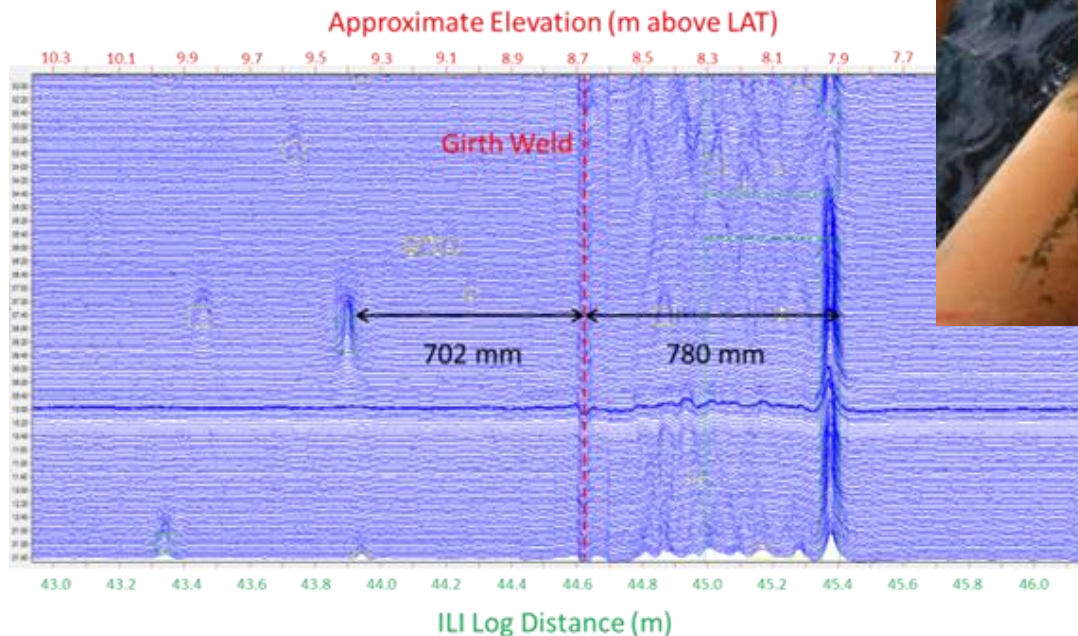
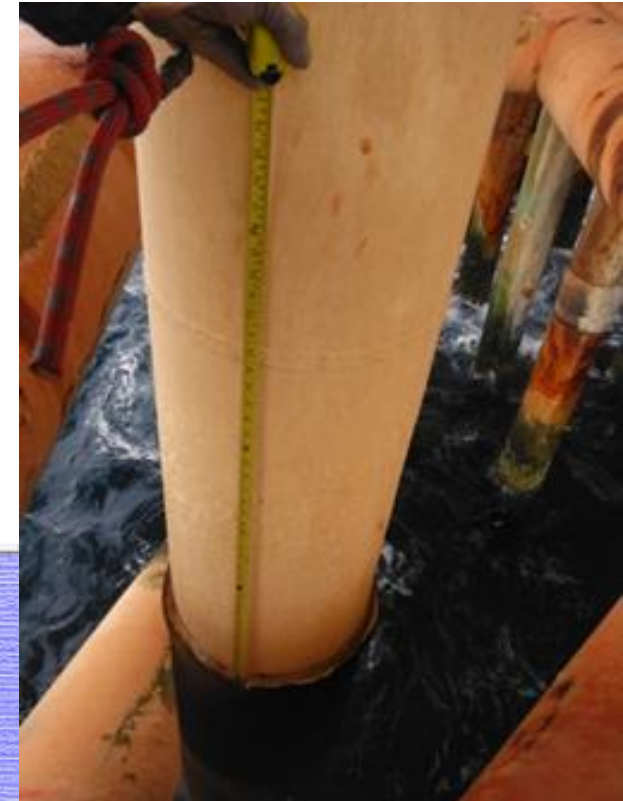
- ILI data aligned with riser schematic
- Alignment used ILI signals to increase accuracy
- Based on alignment, clear guidance was given to investigation team to enable positive identification of riser corrosion

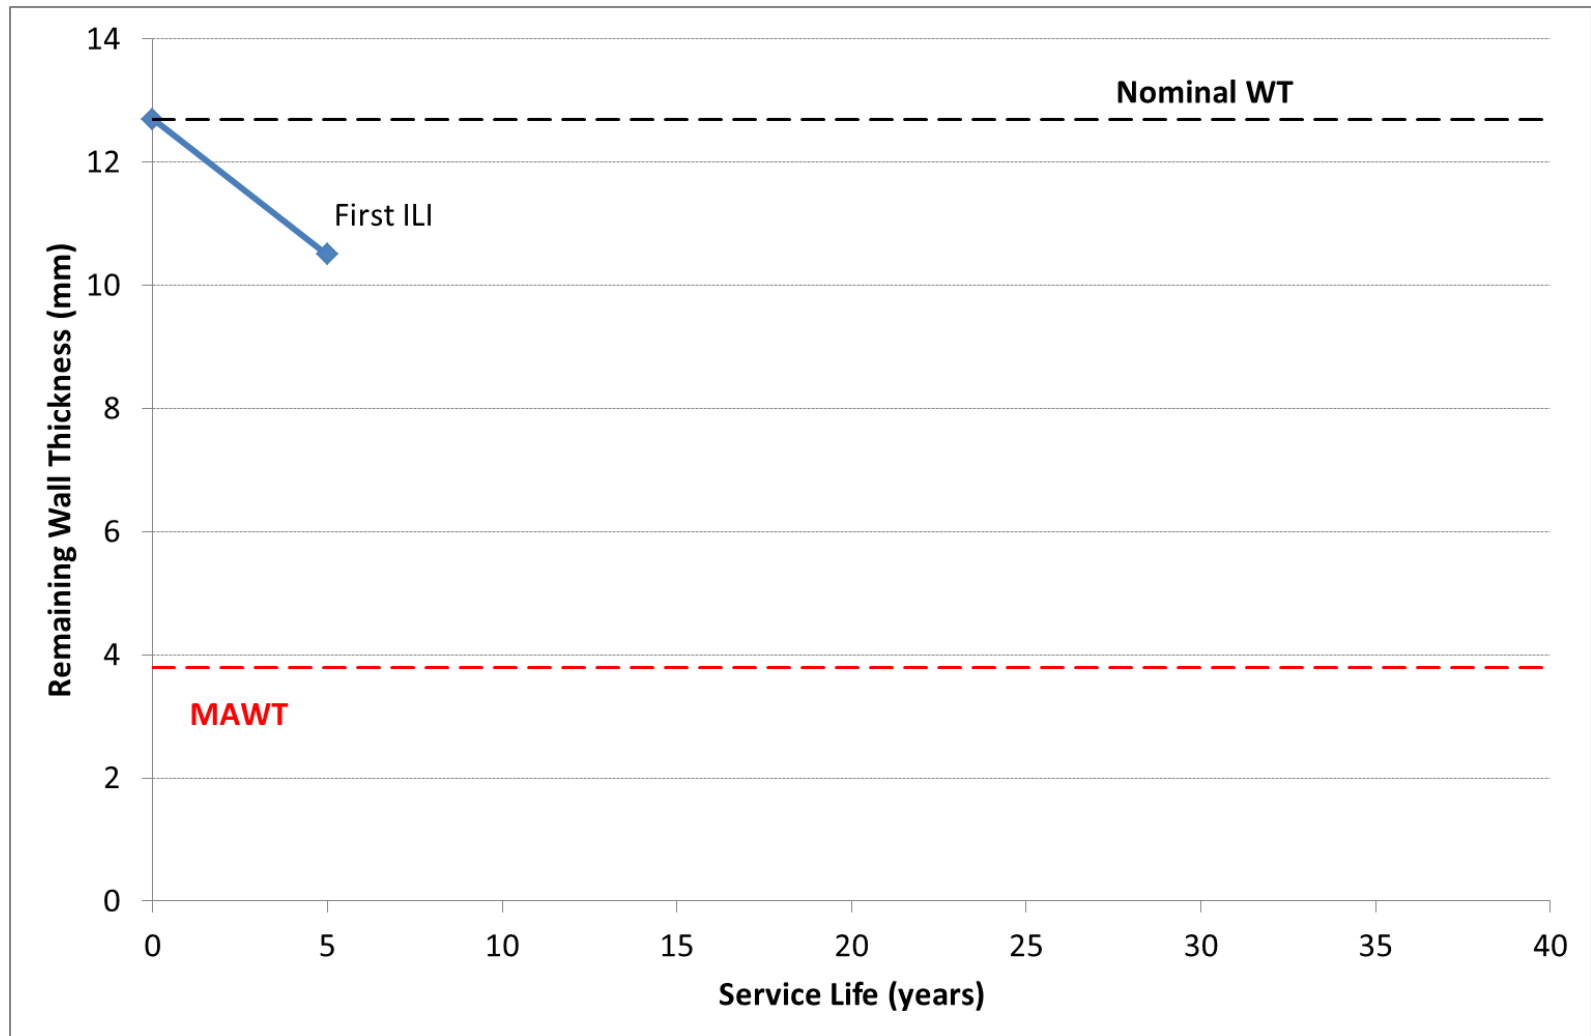
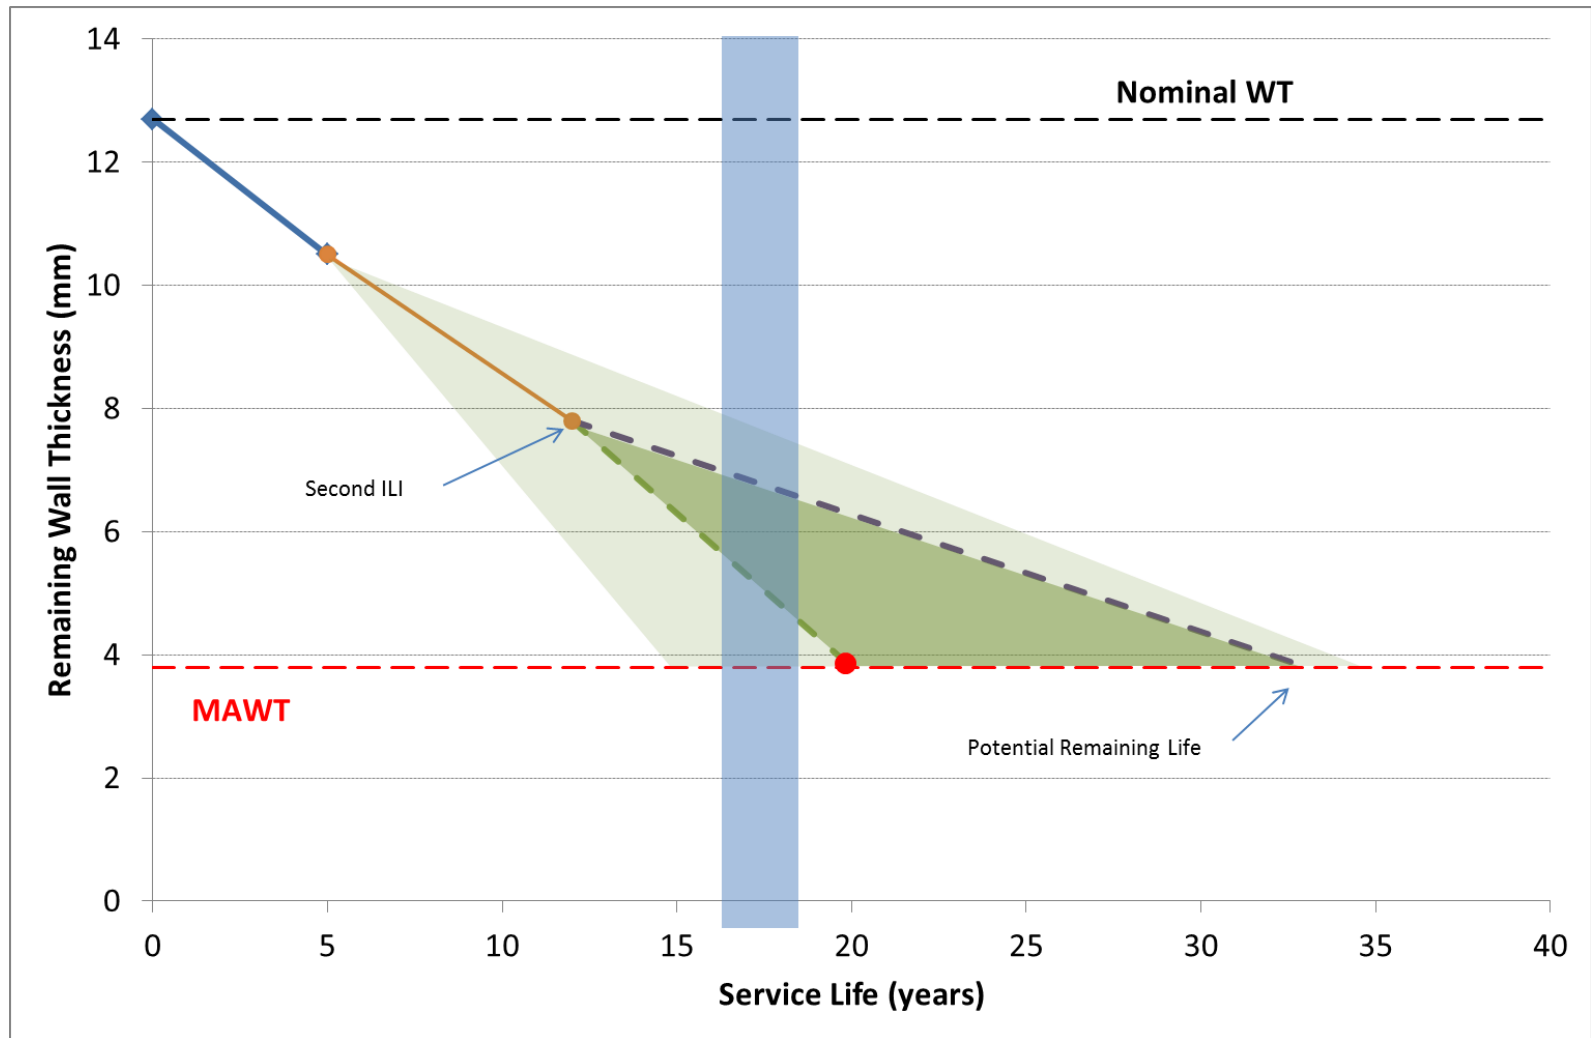
- **Corrosion rates** estimated from comparison of repeat ILI data, supported by corrosion modelling (e.g. NORSOK) where feasible (i.e. dominant mechanism is sweet corrosion)
- **Future** corrosion rates critically dependent on effectiveness of corrosion management and compliance with performance targets (e.g. C.I. injection)
- Two primary requirements from remaining life analysis:
  1. To determine a suitable timeframe for re-inspection based on a conservative estimate of corrosion growth rate
  2. To estimate the potential remaining life of the pipeline based on a less conservative / more representative corrosion growth rate

Note: Remaining life for offshore pipelines normally defined as the time until the most significant defect is predicted to exceed critical dimensions
