RESCUE PIGGING CASE STUDY: AGAINST ALL ODDS AND THE CLOCK

By: Andy Studman, Shell International Ltd (UK), Jim Evans, Pigtek Limited (UK), Aidan O'Donoghue, Pipeline Research Limited (UK)

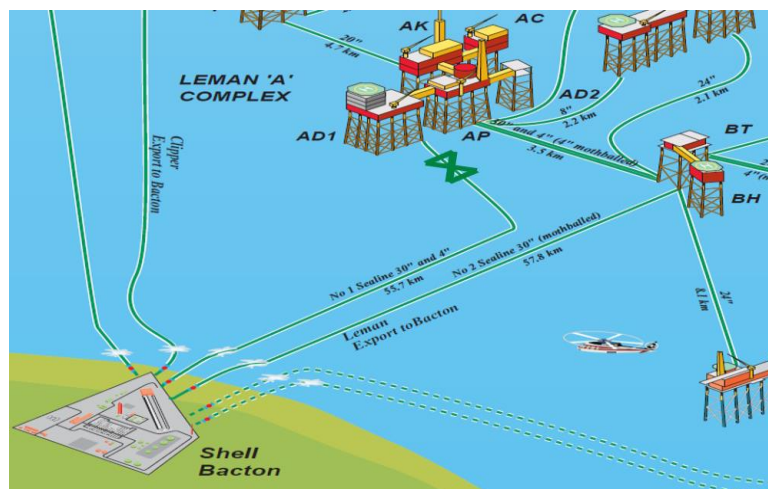
Shell UK operates a 30-inch wet gas pipeline from Leman A in the Southern North Sea to the Bacton gas terminal in Norfolk, England. The field is approximately 55 km from shore. The 30-inch pipeline was built in 1967. Multiphase gas, condensate with MEG and water is transported to shore for processing and onward distribution. The line is sphered daily to remove bulk liquids. If sphering is unavailable, then liquids will build up and the line pressure loss will increase eventually making gas flow difficult.

Downstream of the platform there is a subsea isolation valve (SSIV) which is a full-bore ball valve and is used to prevent bulk flow from the pipeline to the platform in the event of an emergency. The pipeline water depth at Leman A is circa 35 to 45 m water depth and the line then rises slowly to the receipt facility at Bacton.

Figure 1: Leman – Bacton Pipeline System Overview

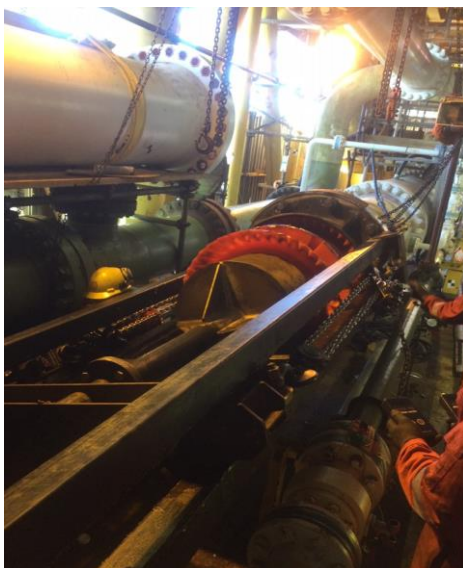
In order to load the pig into the pipeline, a 30-inch spool needed to be removed topside. In its place a pig loader of the same length was installed. The loader was bolted to the pipe flanges either side and secured. The pig was then placed on the loader and turfers were used to push the pig into the 30-inch line.

Due to the specific nature of the back of the pig, it was not possible to push directly on the rear bumper nose on the pig. To overcome this, a top hat design was incorporated to allow the device to push on the rear spacer. (see Figure 4 bottom left photo) In order to aid insertion, the pig was greased allowing it to slide in easier. The whole operation was simulated at the Pigtek testing site and the offshore team were present to allow their procedures to be finalised.

Figure 5: Rescue Pig Loading

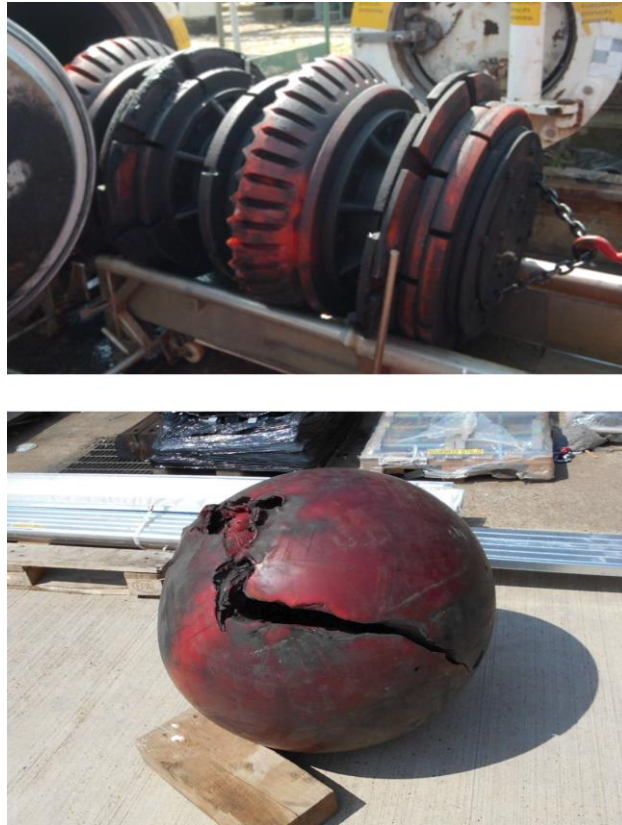
The pig successfully negotiated the pipeline and pushed the stricken sphere out at Bacton. The sphere was recovered mainly in one piece but with a large rip in it. This was likely due to traversing the partially closed SSIV and resulted in a large leakage area and a certain amount of ovality which added to the friction. The combination of leakage area and additional friction meant that the gas flow could move past the pig without generating sufficient differential pressure to push it forward. It may have been moving very slowly but it was difficult to tell.

Figure 6: Recovered Damaged Sphere and Rescue Pig
